# Rehabilitation of Longitudinal Joints in Double-Tee Girder Bridges

REHABILITATION OF LONGITUDINAL JOINTS IN DOUBLE-TEE  
GIRDER BRIDGES

A thesis in partial fulfillment of the requirements for the

Major in Civil Engineering

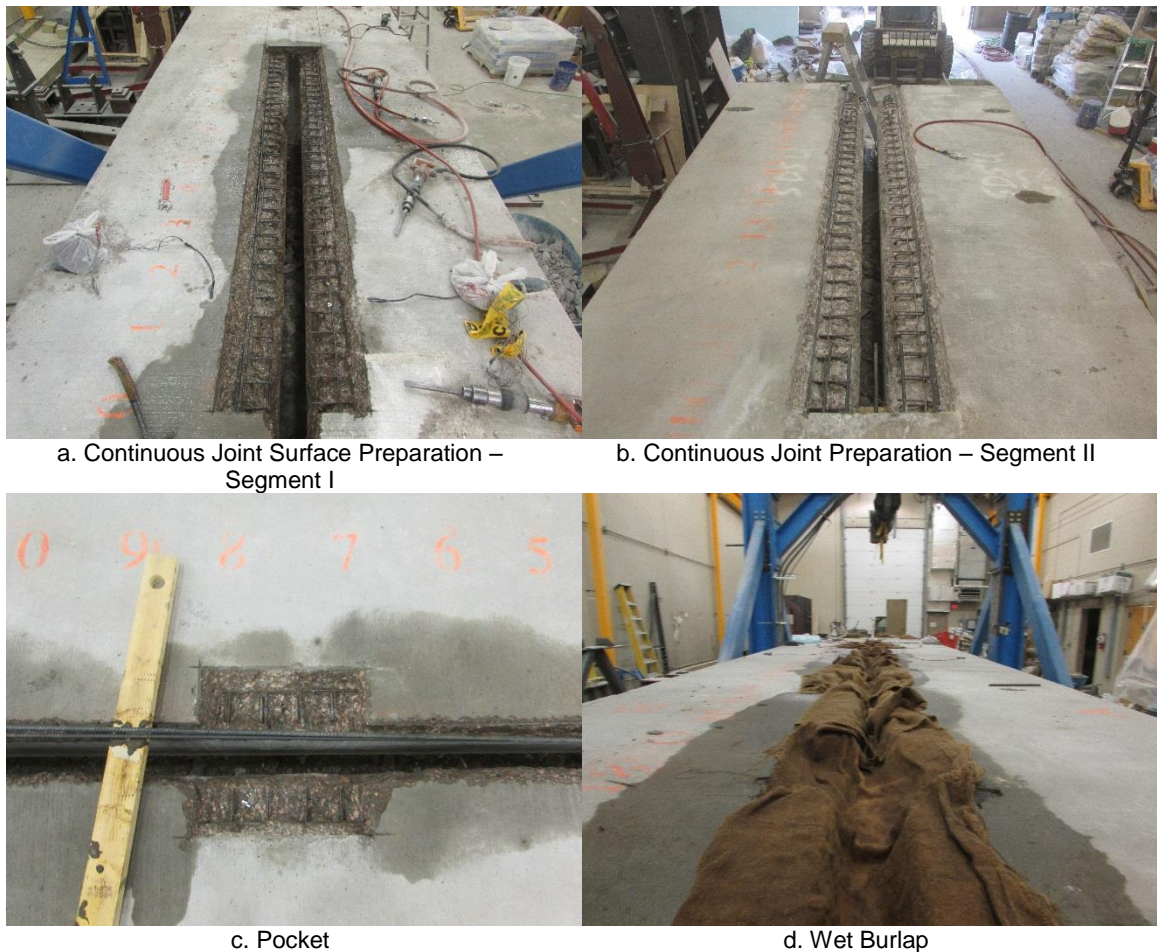
**Figure 6-13. Surface Preparation for Joint Rehabilitation**

After chipping the concrete and exposing the deck reinforcement, the surface was cleaned with compressed air then wetted for 24 hours (Fig. 6-13). Sand-blasting should be used to improve the bond. However, it wasn't feasible in this experimental study due to laboratory restrictions.

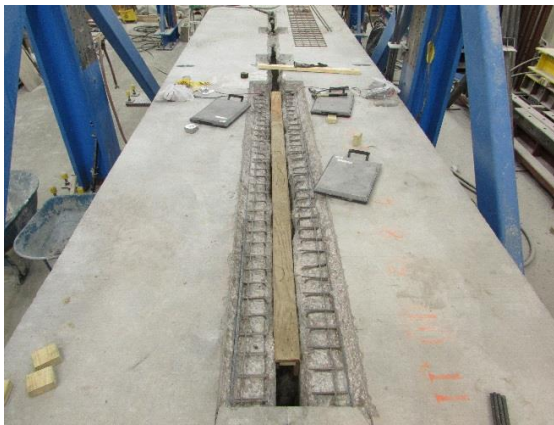
a. Top View  
Continuous Joint Segment I Formwork

The as-built continuous joint reinforcement (Fig. 6-14e) was 4 in. by 4-in., D8/D8 welded wire mesh with a total width of 16 in. installed 2.25 in. below the deck surface. A minimum splice length of 5 in. was provided on the both sides of the joint. The pocket reinforcement (Fig. 6-14f) was 12.5-in. long in both directions and was installed with a clear cover of 2.75 in. from the top of the deck. A minimum splice length of 3 in. was provided in the transverse direction of the bridge in each pocket.

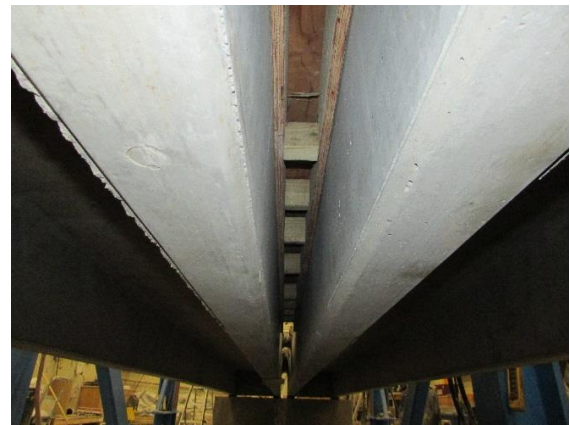
b. Underneath View  
Continuous Joint Segment I Formwork

The formwork for Segment I of the continuous joint was made with plywood with intermediate blocking (Fig. 6-14a-b). A Styrofoam (Fig. 6-14c) was used to separate the segments. A significant LMC leak was noticed using this method. For Segment II of the continuous joint, the formwork was modified using Styrofoam (Fig. 6-14d) and no leak was observed.

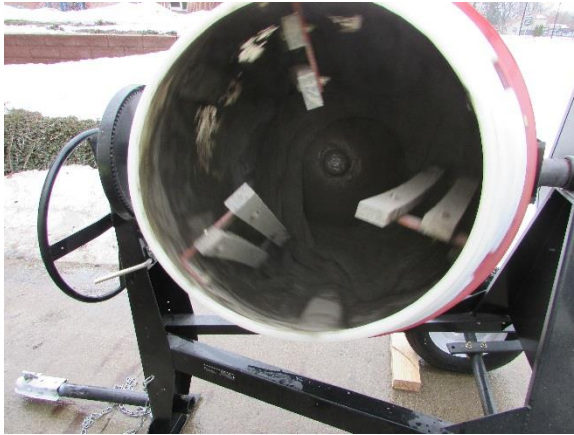
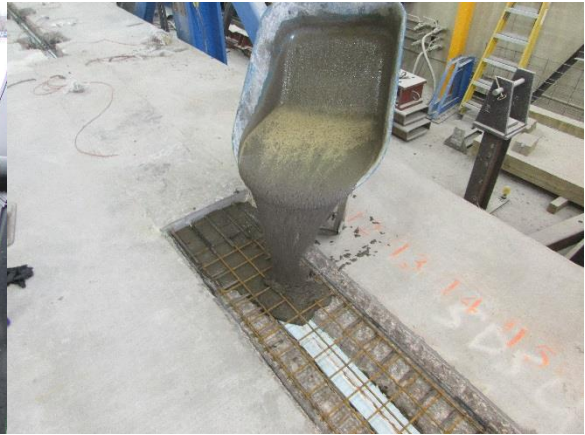
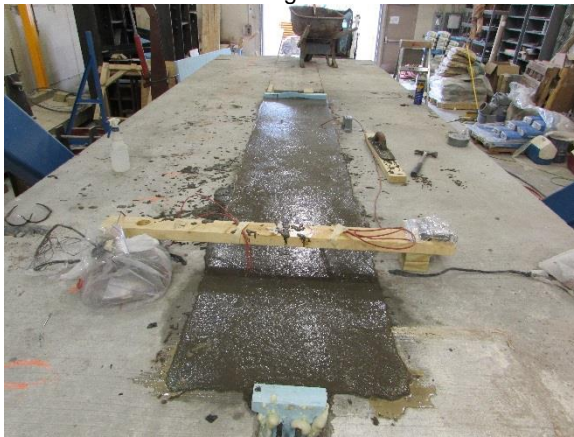
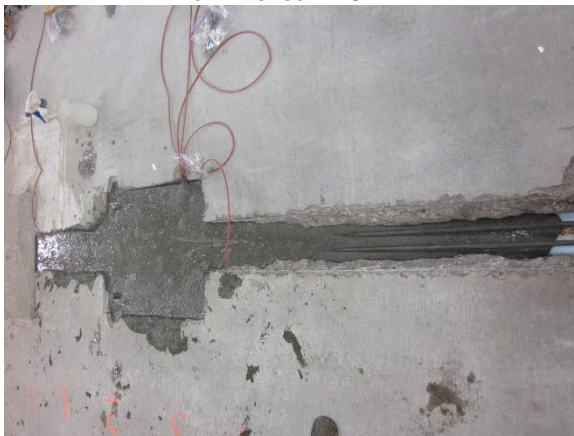
After pouring, the joints were covered with wet burlaps and plastic sheets. The test specimen was cured for 14 days to allow UHPC to gain a compressive strength of 18 ksi.

a. Mixing LMC

b. Pouring LMC

c. Finished LMC

e. Pouring UHPC

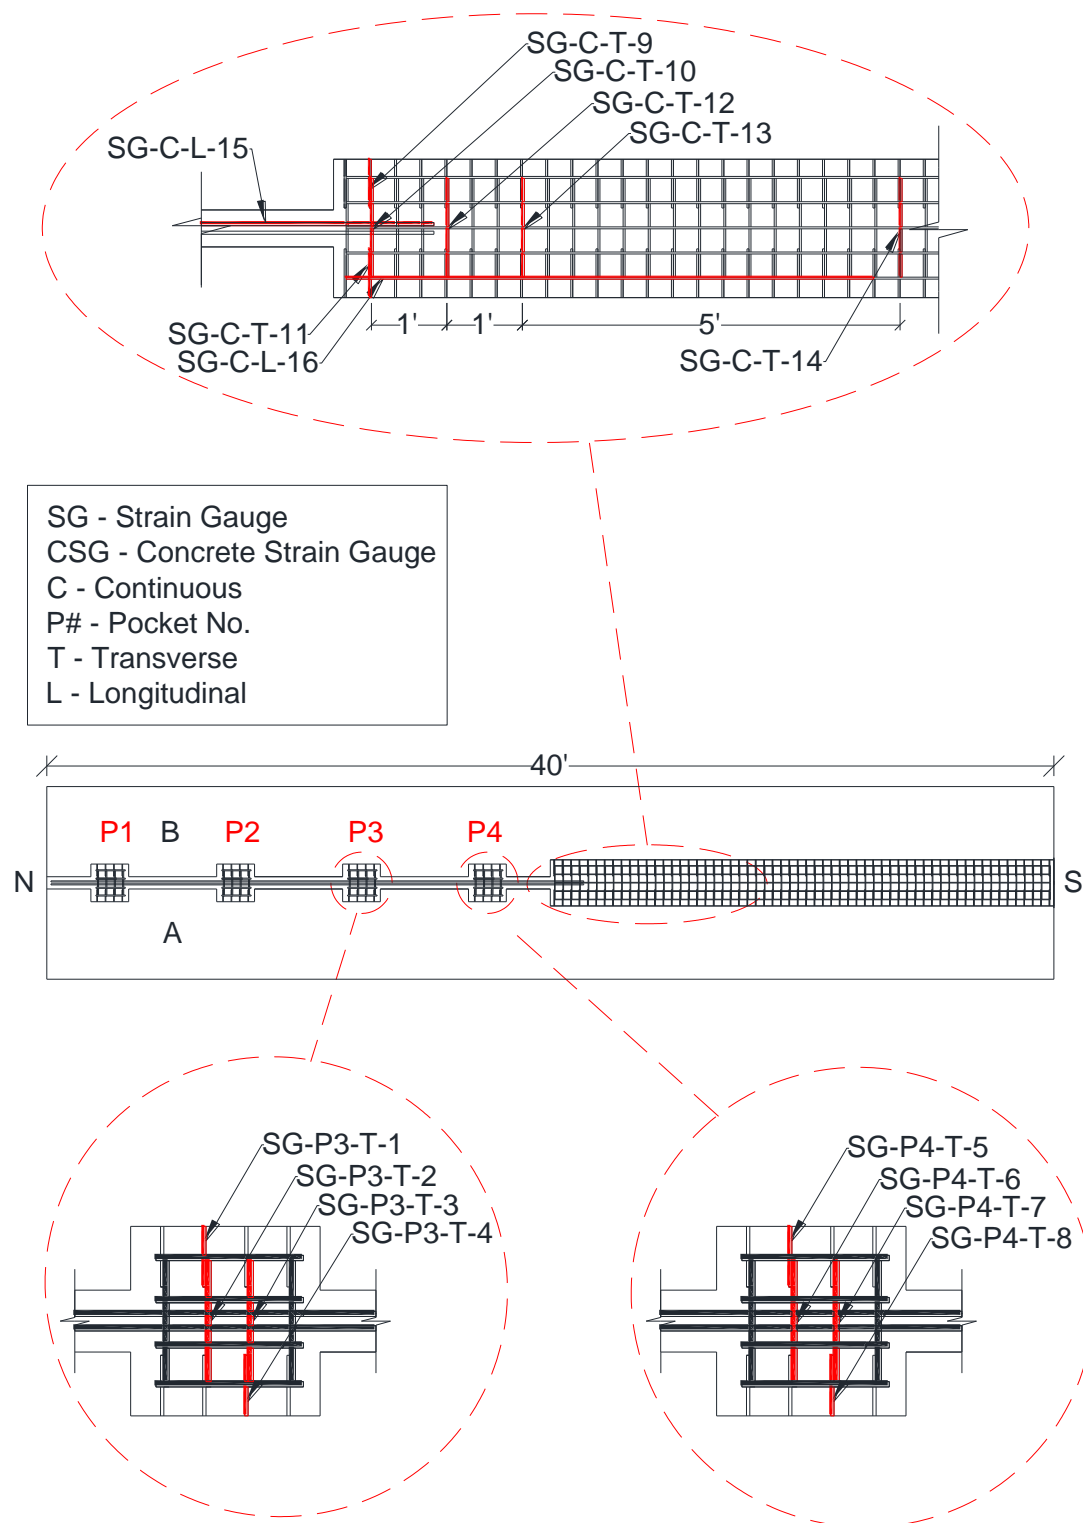
Figure 6-16. Rehabilitated Joint Strain Gauge Plan

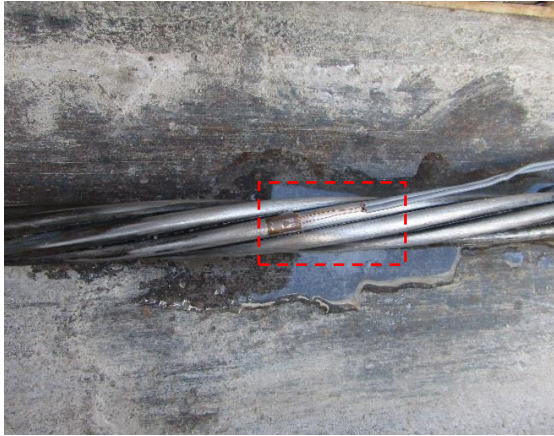
a. Strain Gauge on Prestressing Strand

The prestressed strands were first cleaned by removing all debris and grease. Next, the strands were sanded with fine grit sand paper. After sanding, the surface was cleaned with an acid then neutralized with a base solution. The tendon strain gauges (SG) were placed at the midspan by offsetting them from the center of the girders based on the elongation of the tendons at full tension (31 kips), which was done after strain gauge installation. The gauges were attached to the tendons with an adhesive supplied by the

manufacturer (Fig. 6-18a). Finally, the gauge was waterproofed with a nitrile compound and wrapped with several layers of tape and rubber. The concrete strain gauges (CSG) were placed at the midspan between the welded wire mesh (Fig. 6-18b). The gauges were tied to the wire mesh with wires. Samples of steel reinforcement strain gauges are shown in Fig. 6-18c before casting.

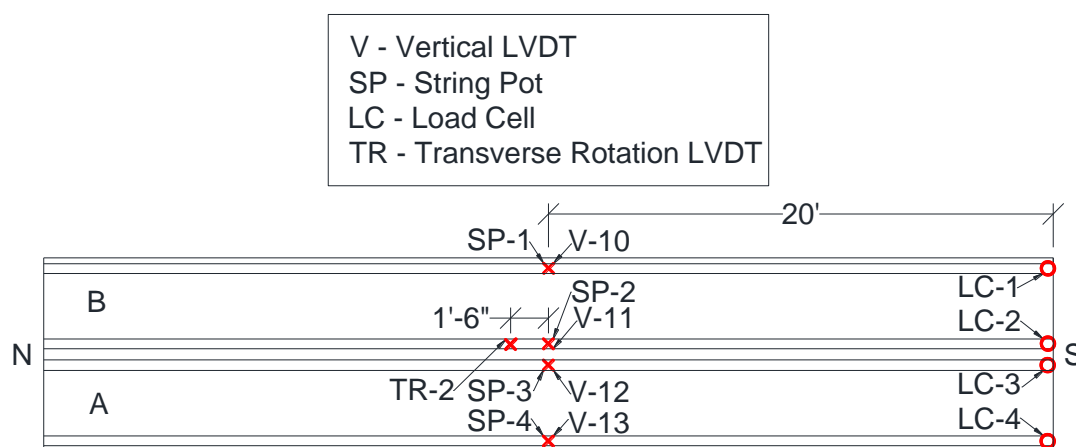
Figure 6-19. LVDT Instrumentation Plan Below Deck

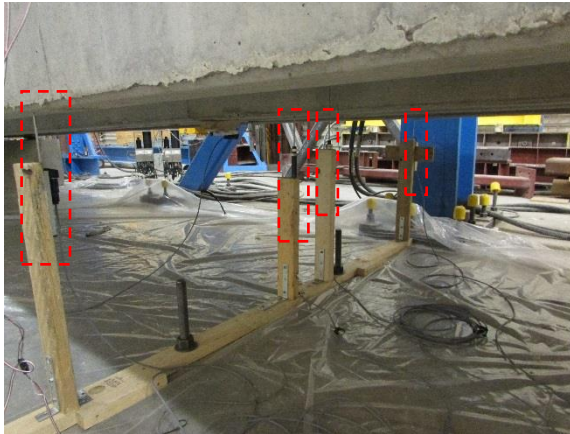
a. Midspan LVDTs

Thirteen LVDTs were used to measure displacements, slippage, and rotations of critical locations in the experiment (Fig. 6-19 and Fig. 6-20). The four midspan LVDTs (Fig. 6-21a) measuring vertical deflection of the stems from the bottom were removed

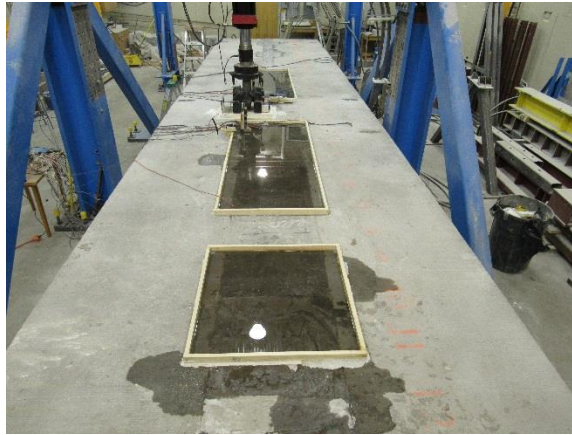
**Figure 6-24. Water Dams on Rehabilitated Joint**

loading area. Water dams (Fig. 6-24) were formed above the rehabilitated longitudinal joint to identifying cracking.

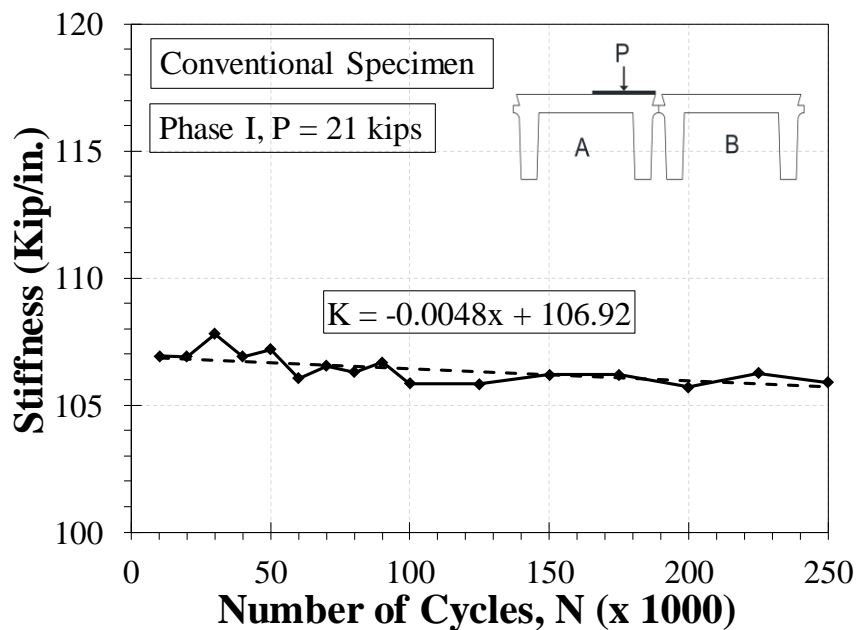
Figure 7-2. Stiffness Degradation during Fatigue II Testing of Conventional Double-Tee Bridge Specimen

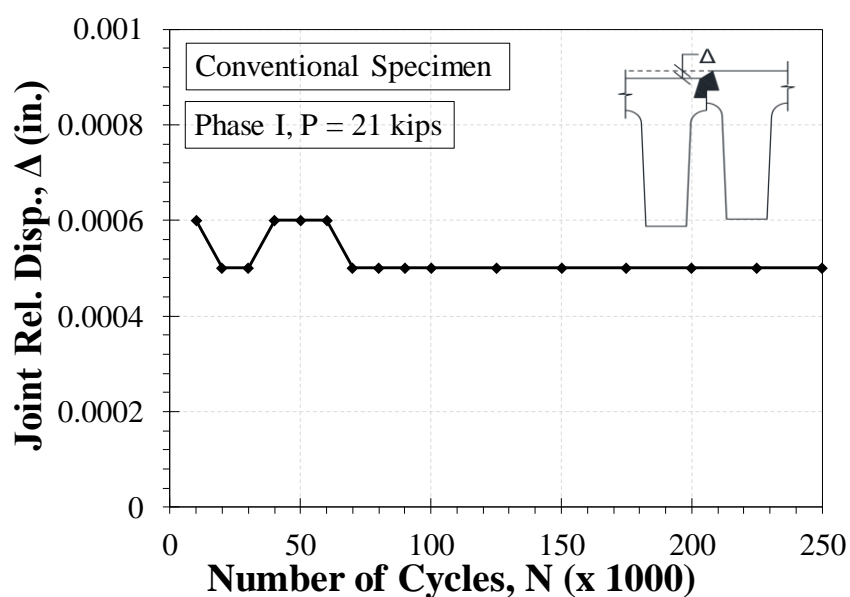
Figure 7-3. Longitudinal Joint Relative Displacement for Conventional Double-Tee Bridge Specimen during Fatigue II Testing

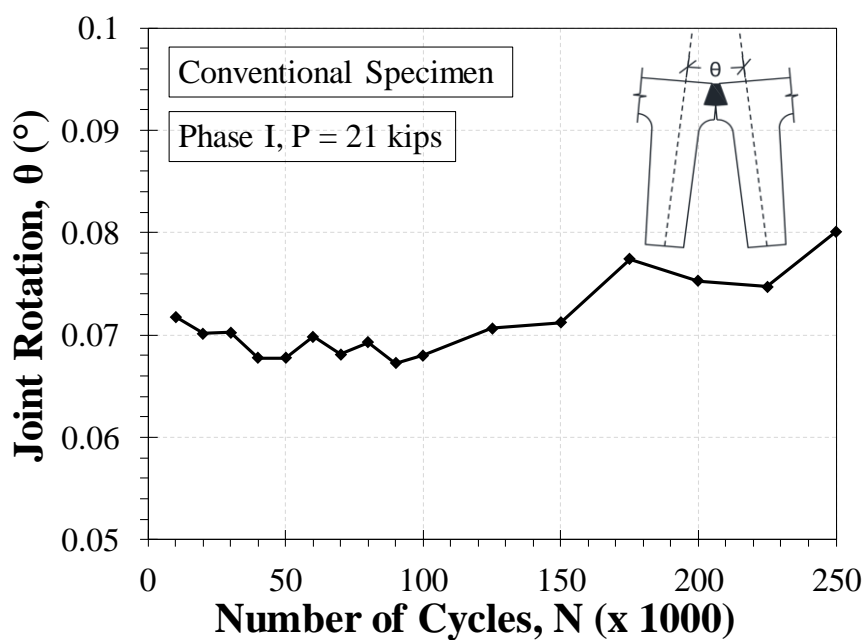
Figure 7-4. Girder-to-Girder Joint Rotation for Conventional Double-Tee Bridge Specimen during Fatigue II Testing

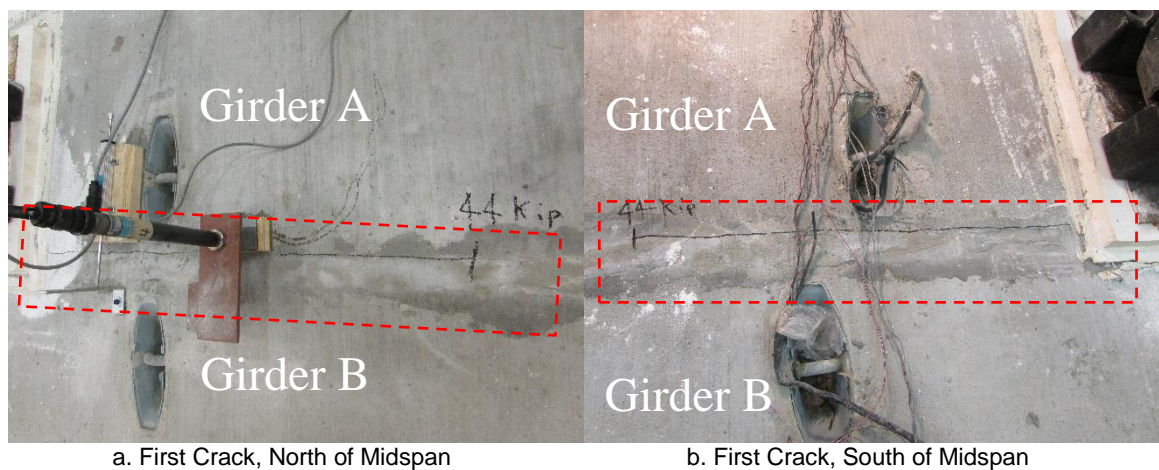
**Figure 7-5. Girder-to-Girder Joint Cracking of Conventional Double-Tee Bridge Specimen**

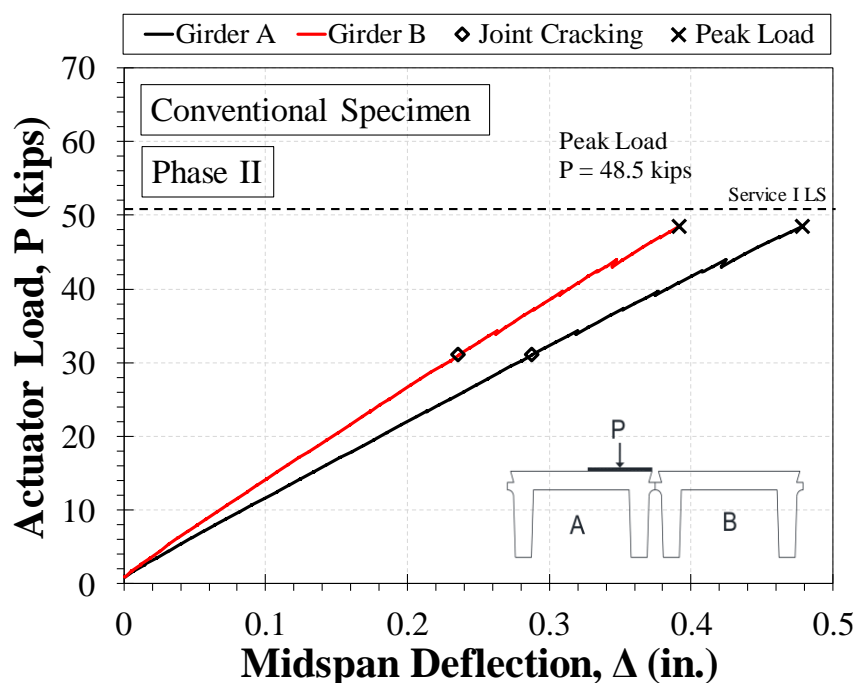
Figure 7-6. Force-Displacement Relationship for Conventional Double-Tee Bridge Specimen during Joint Crack Strength Testing

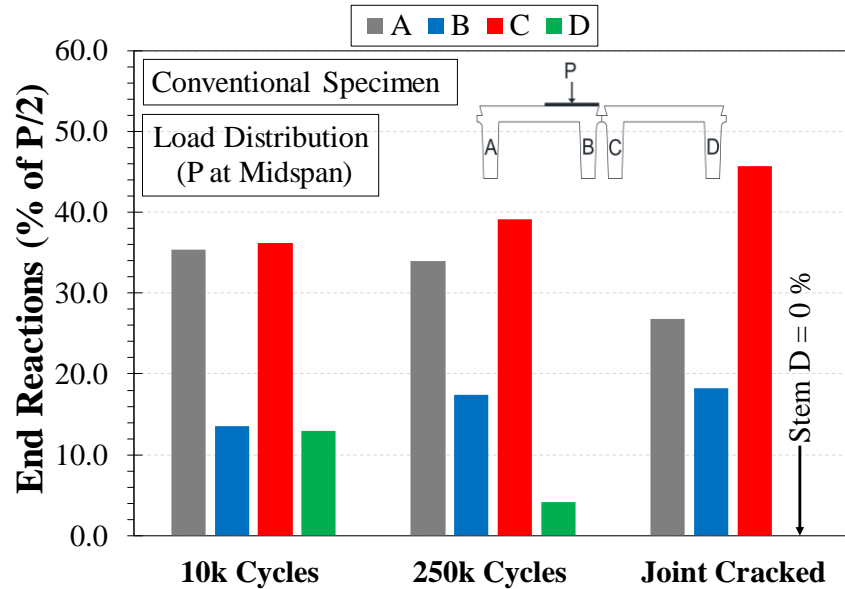
Figure 7-7. Girder Load Distribution for Conventional Double-Tee Bridge Specimen

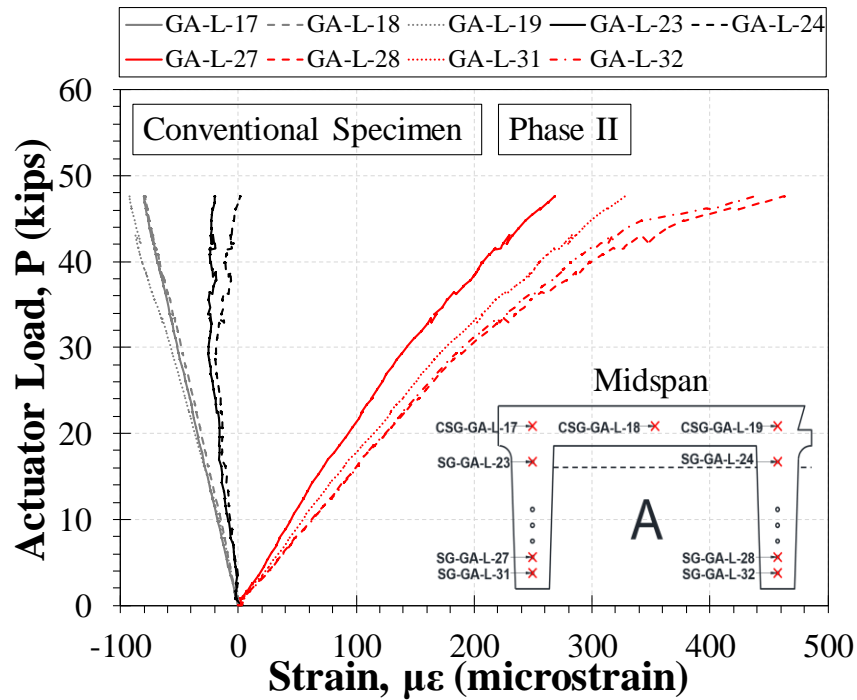
**Figure 7-8. Measured Strains of Loaded Girder in Conventional Double-Tee Bridge Specimen during Joint Crack Strength Testing**

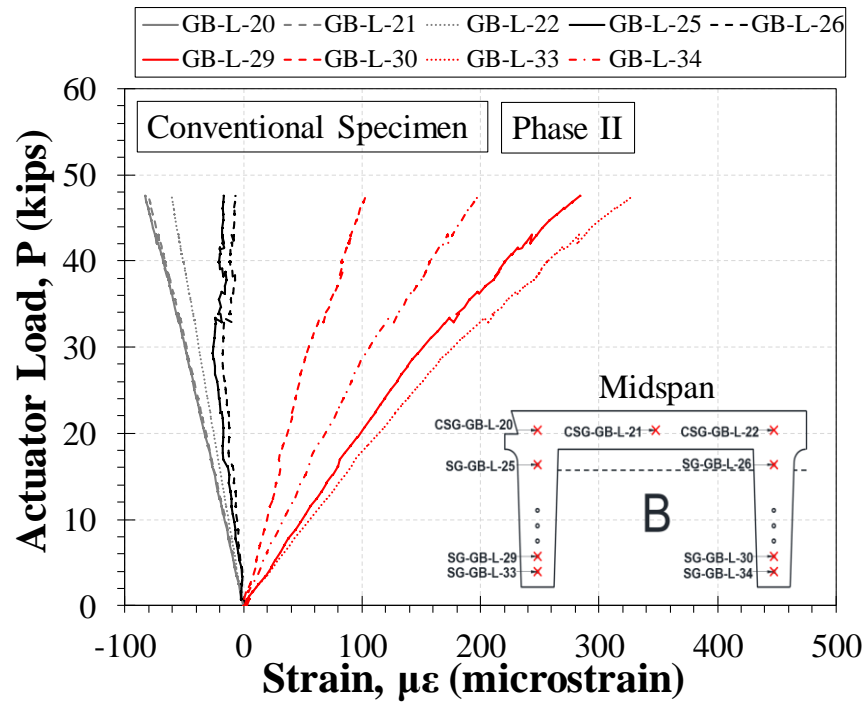
**Figure 7-9. Measured Strains of Girder B in Conventional Double-Tee Bridge Specimen during Joint Crack Strength Testing**

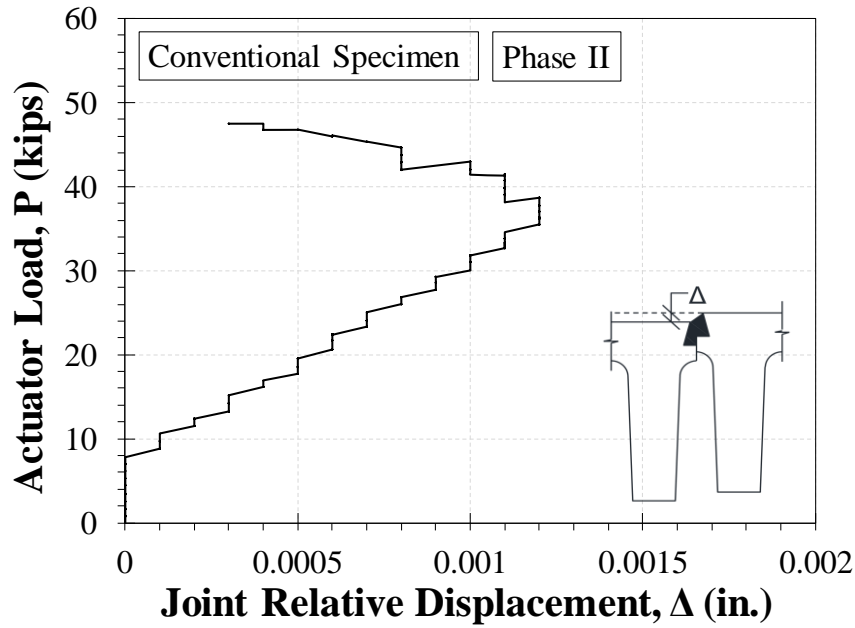
Figure 7-10. Longitudinal Joint Relative Displacement for Conventional Double-Tee Bridge Specimen during Joint Crack Strength Testing

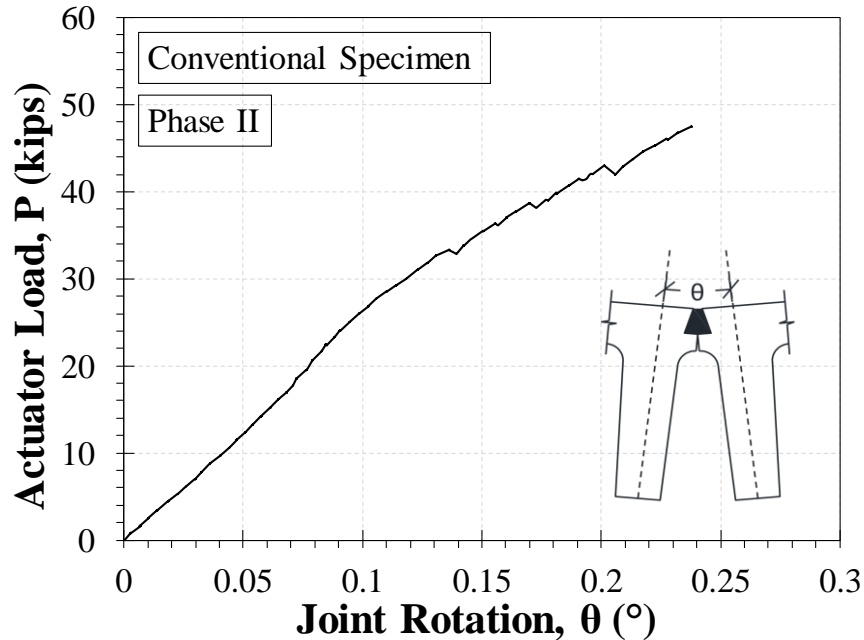
Figure 7-11. Girder-to-Girder Joint Rotation for Conventional Double-Tee Bridge Specimen during Joint Crack Strength Testing

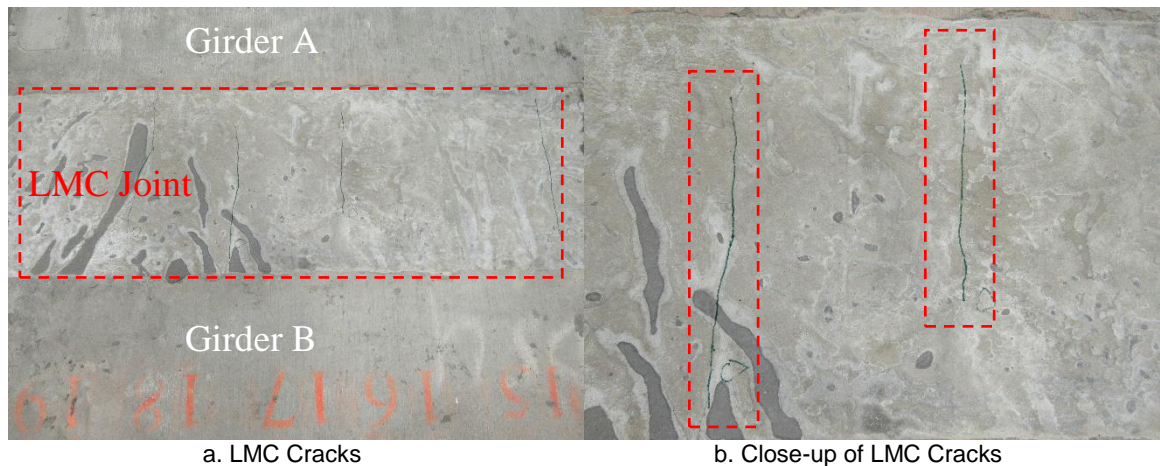
**Figure 7-12. Transverse Cracks in the Continuous Joint of Rehabilitated Double-Tee Bridge Specimen Prior to Testing**

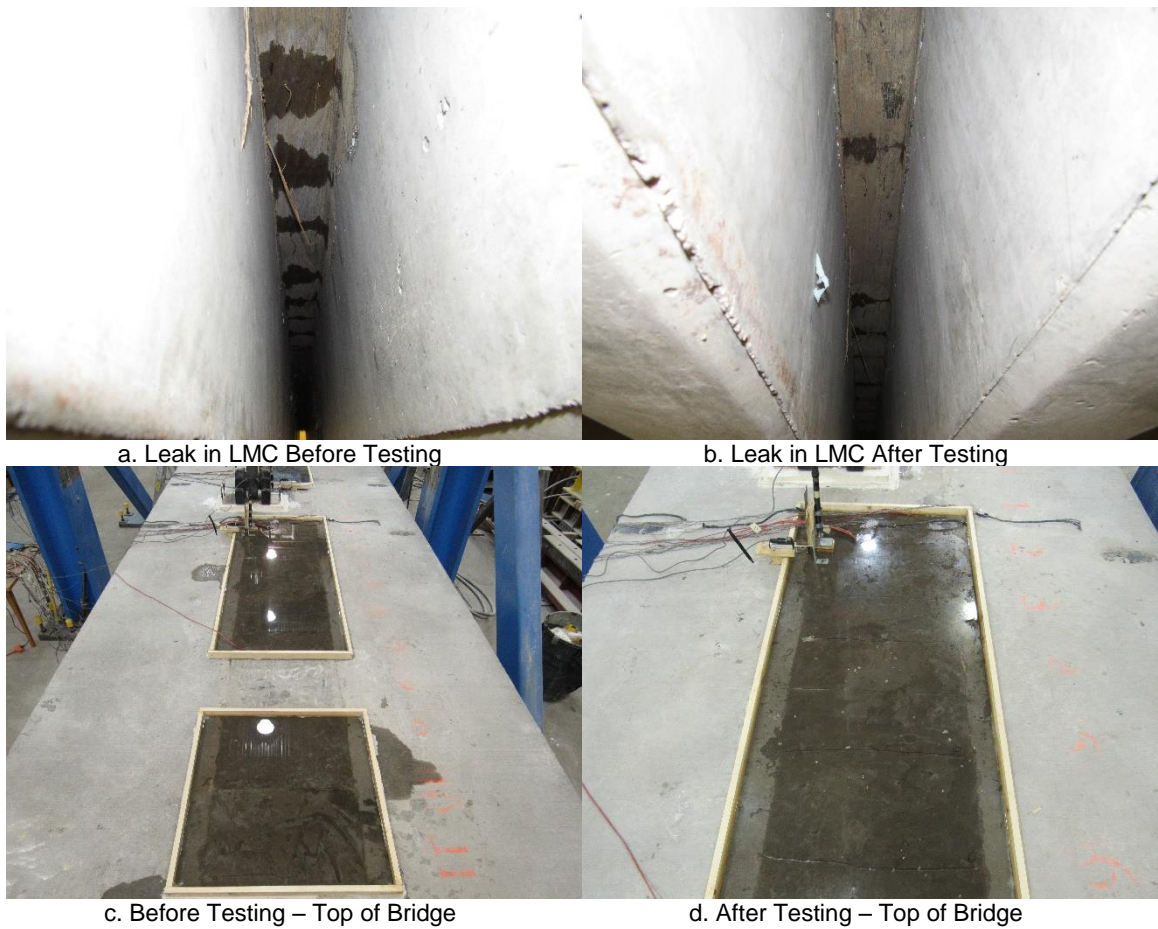
**Figure 7-13. Damage of Continuous Joint of Rehabilitated Double-Tee Bridge Specimen during Fatigue II Testing**

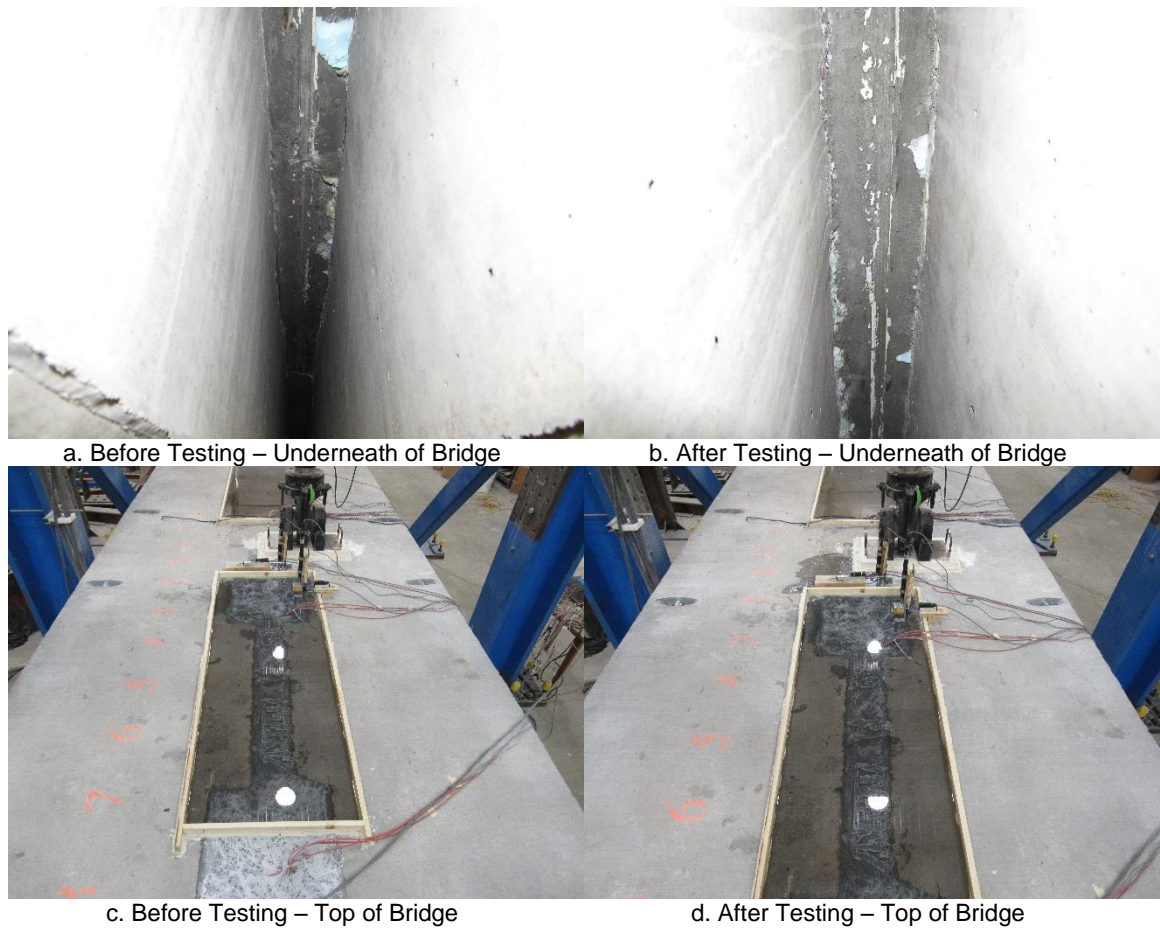
**Figure 7-14. Damage of UHPC Pocket Joints of Rehabilitated Double-Tee Bridge Specimen during Fatigue II Testing**

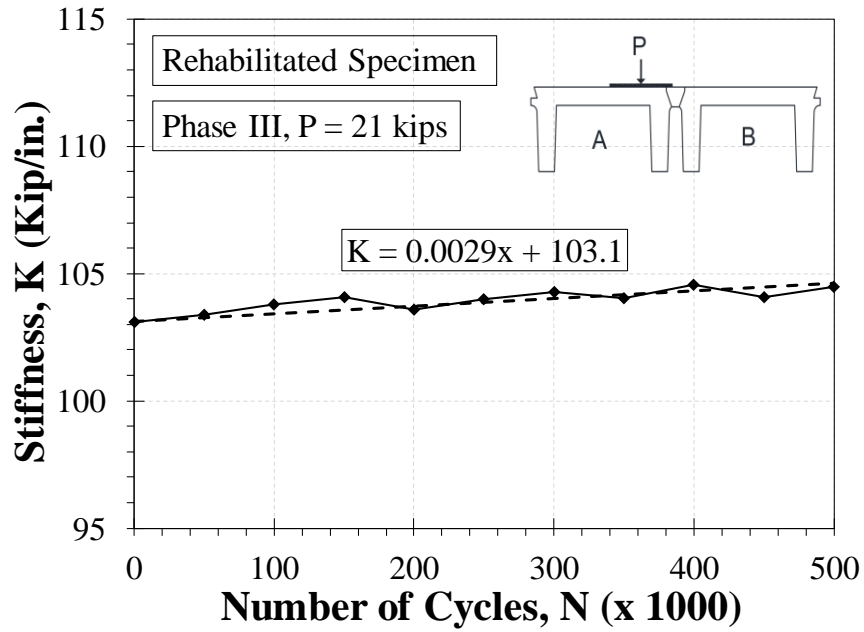
**Figure 7-15. Stiffness Degradation during Fatigue II Testing of Rehabilitated Double-Tee Bridge Specimen**

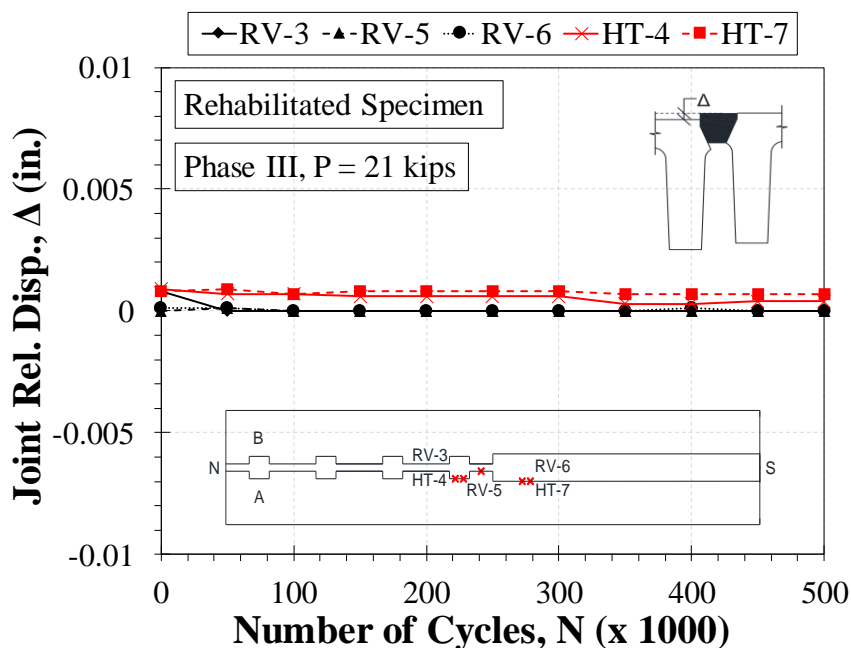
Figure 7-16. Longitudinal Joint Relative Displacement for Rehabilitated Double-Tee Bridge Specimen during Fatigue II Testing

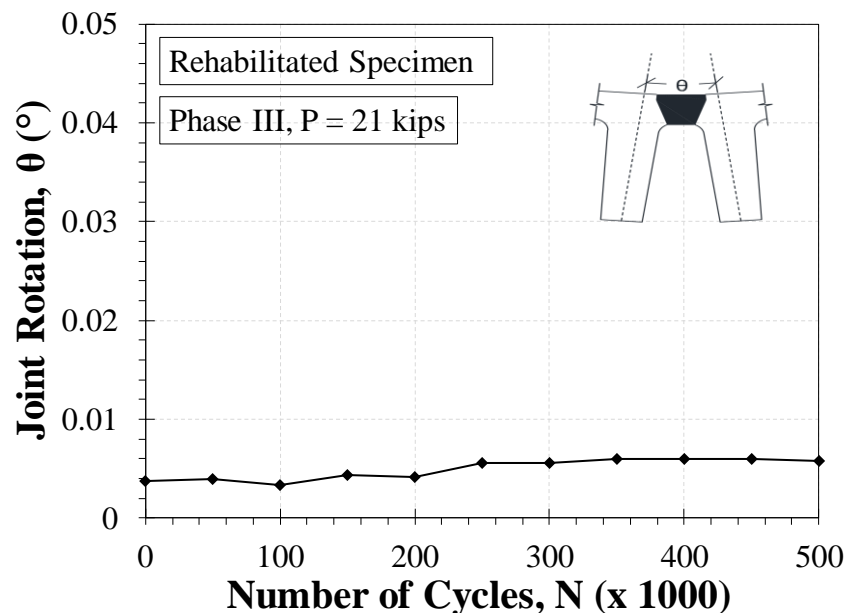
Figure 7-17. Girder-to-Girder Joint Rotation for Rehabilitated Double-Tee Bridge Specimen during Fatigue II Testing

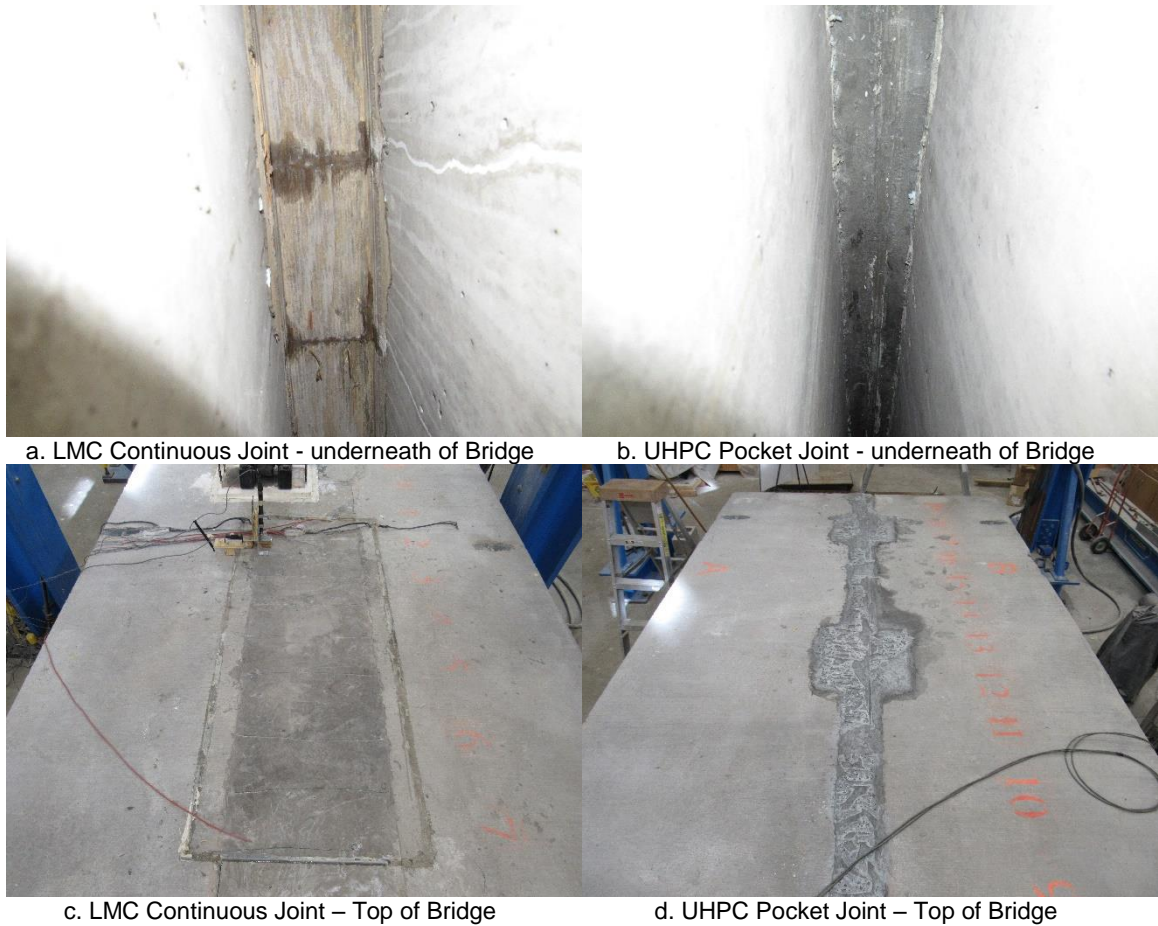
**Figure 7-18. Damage of Rehabilitated Double-Tee Bridge Specimen after Fatigue I Testing**

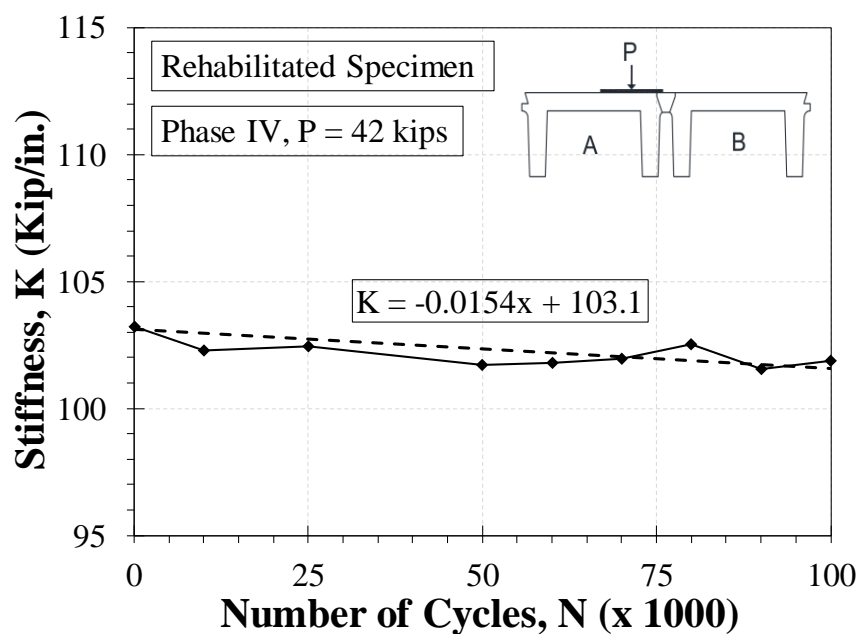
Figure 7-19. Stiffness Degradation for Rehabilitated Double-Tee Bridge Specimen during Fatigue I Testing

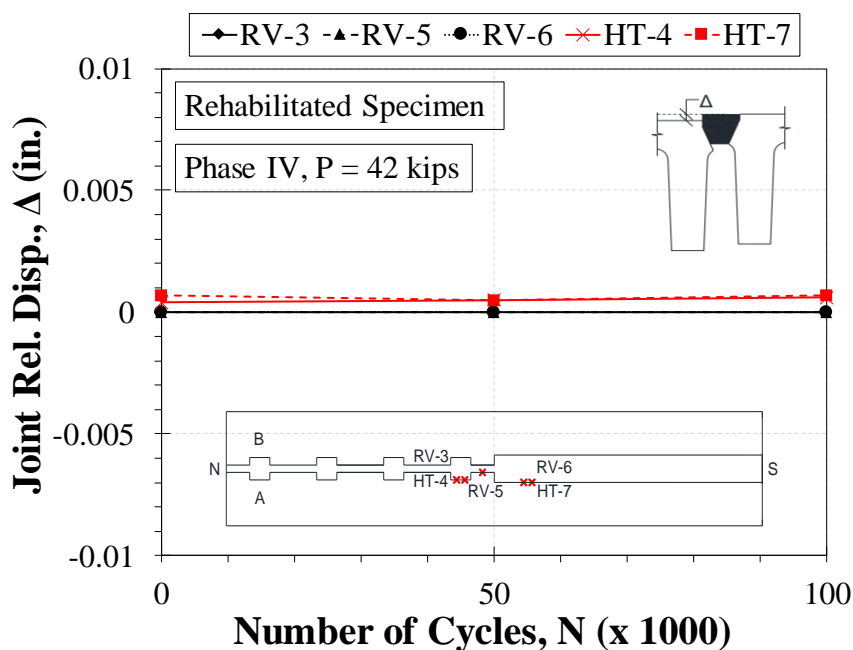
Figure 7-20. Longitudinal Joint Relative Displacement for Rehabilitated Double-Tee Bridge Specimen during Fatigue I Testing

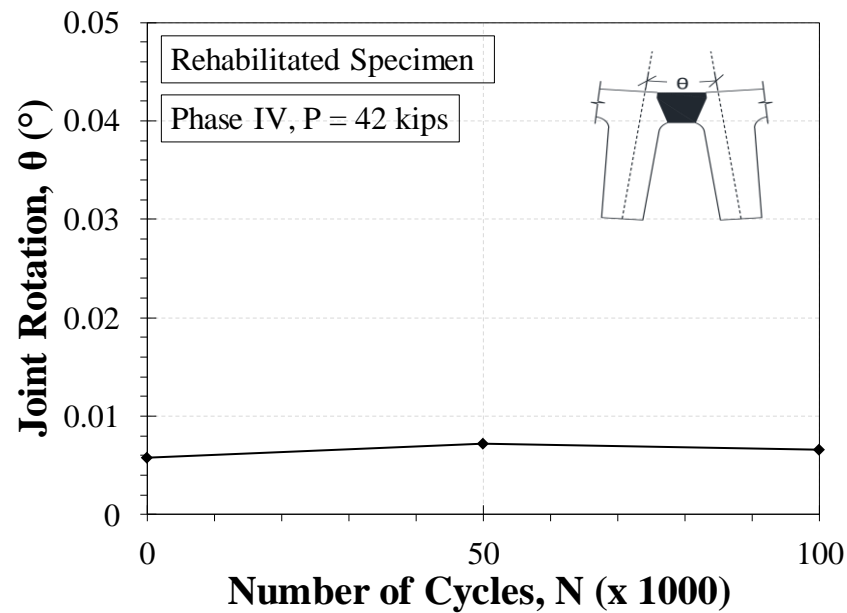
Figure 7-21. Girder-to-Girder Joint Rotation for Rehabilitated Double-Tee Bridge Specimen during Fatigue I Testing

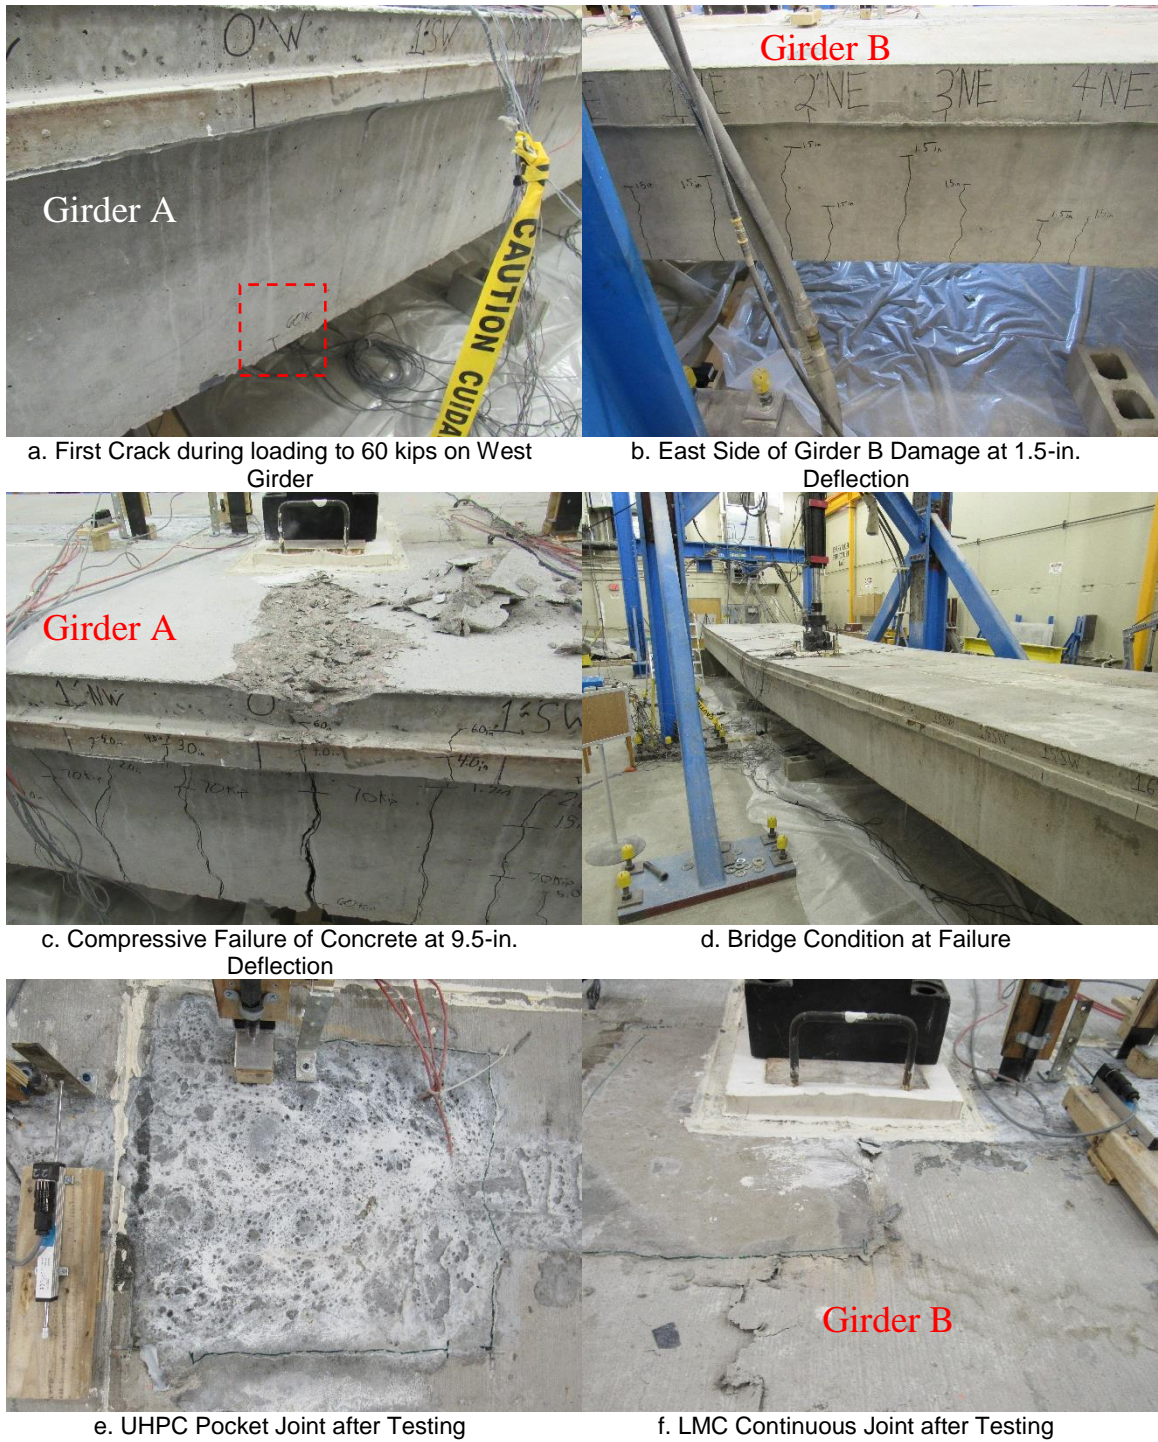
**Figure 7-22. Damage of Rehabilitated Double-Tee Bridge Specimen during Strength Testing**

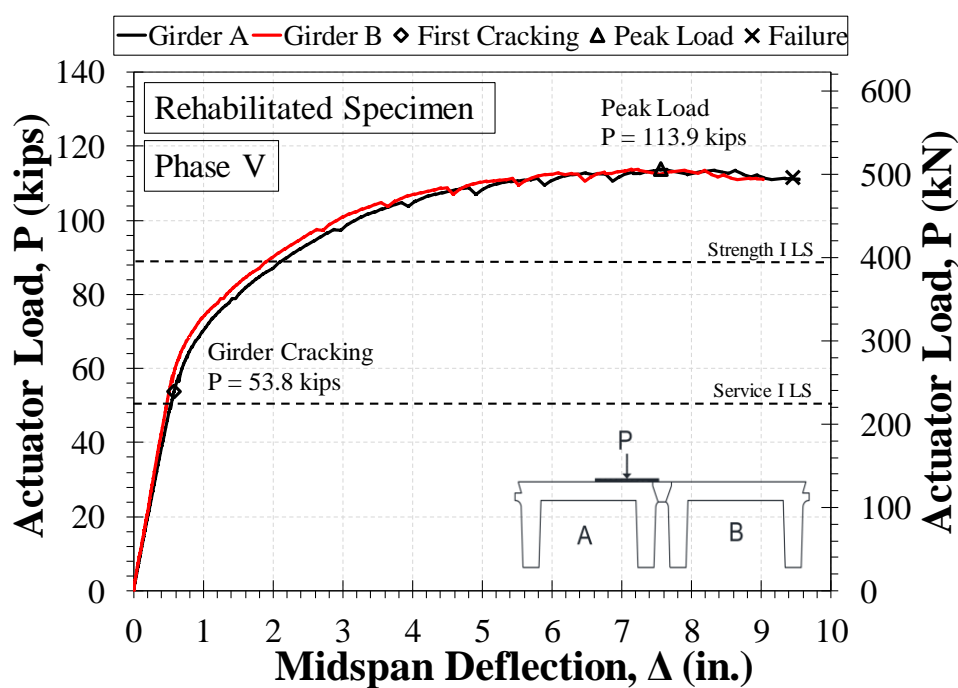
Figure 7-23. Force-Displacement Relationship for Rehabilitated Double-Tee Bridge Specimen during Strength Testing

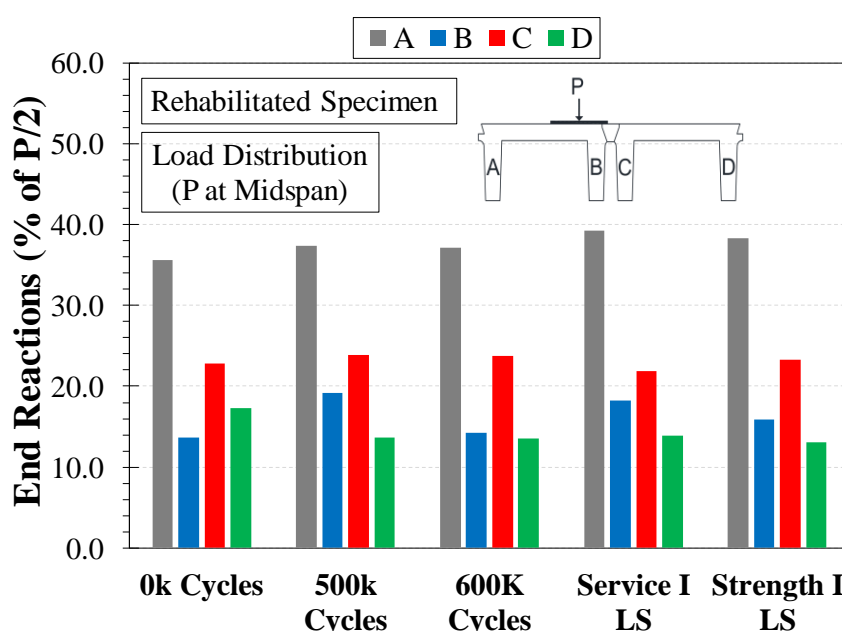
Figure 7-24. Girder Load Distribution for Rehabilitated Double-Tee Bridge Specimen

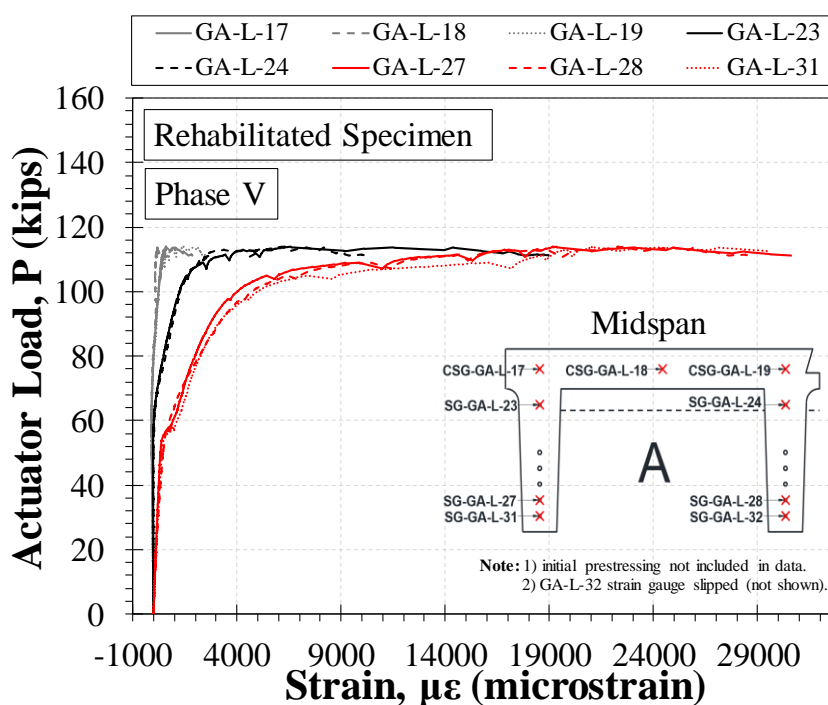
**Figure 7-25. Measured Strains of Loaded Girder in Rehabilitated Double-Tee Bridge Specimen during Strength Testing**
